PUBLIC WATER SYSTEM ASSET MANAGEMENT PLAN | MAY 2015

Town of Exeter, New Hampshire

**Public Water System Asset Management Plan
Exeter, New Hampshire**

Subject: Public Water System Asset Management Plan
Town of Exeter, New Hampshire
T&H Project No. 2703

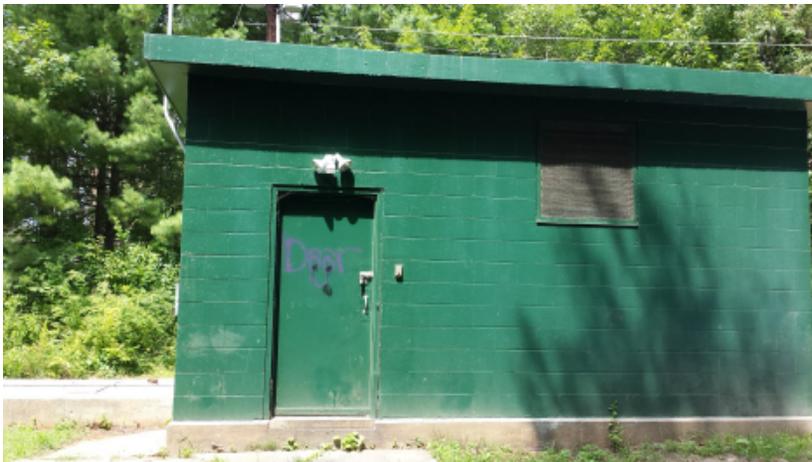
The Exeter River Pump Station was constructed between 1972 and 1974. It is located on the eastern bank of the Exeter River and accessed by a ¼ mile road off High Street. The entrance

to the access road is gated and locked. The road serves as a right-of-way through Phillips-Exeter Academy owned land. The Exeter River Pump Station is operated from April to October each year. The water is pumped from the station through a 12-inch diameter main to the SWTP on Portsmouth Avenue.

The building consists of a concrete block structure with a flat concrete roof atop a subgrade basement and vault that houses an intake pipeline, manually-actuated sluice gate, stationary water screen, discharge piping, valving, and appurtenances. The building is locked and requires a key separate from the access gate to gain access. The facility houses two vertical turbine pumps. The facility is also equipped with a Badger Meter magnetic flowmeter, SCADA panel, and NEMA Type 1 electrical panels.

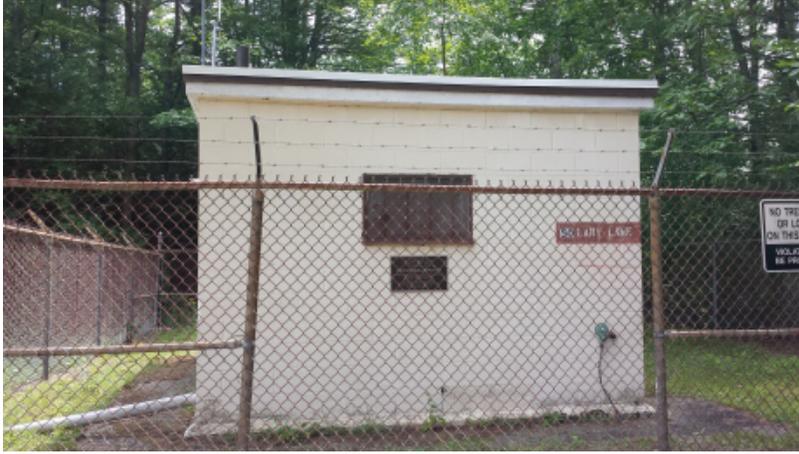
The Lary Lane Well was constructed in 1958. The 24-inch by 18-inch diameter gravel packed well is constructed to a depth of 94 feet. The well screen extends from 79 feet to 94 feet deep, with a total length of 15 feet. The screen slot opening width is 0.080 inch for the

top 5 feet and 0.120 inch for the bottom ten feet. The screen is made of Everdur, an alloy consisting of 96 percent copper. This material was a common well screen material prior to the introduction of stainless steel as the industry standard.

The facility is surrounded by a barbed wire topped chain link fence and requires a key to gain access through the locked gate. The fence is signed with a ‘No Trespassing or Loitering on This Property: Violators Will Be Prosecuted’ notice. The building consists of a masonry block structure atop a subgrade basement that houses discharge piping, valving, and appurtenances.

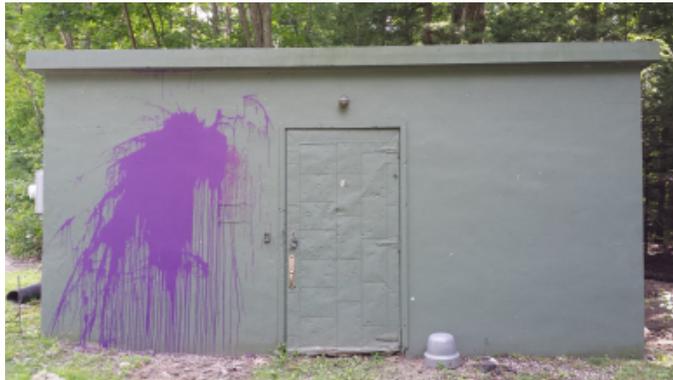
The Gilman Park Well was constructed in 1951. The well is 51-feet deep and 24-inches in diameter with a 5 foot long well screen. The well was last used in 1959 and is currently inactive, but in the process of being reactivated. The rehabilitation will include a new coat of paint on the building exterior. The facility is a concrete block building with a concrete roof and is equipped with a unit heater. The well was reportedly

abandoned due to high iron content and taste and odor issues stemming from the presence of hydrogen sulfide. Currently the site is being restored and the building is being retrofitted with a new roof and pump to feed the new groundwater treatment facility which should be online by September 2015. A 14-inch diameter HDPE raw water transmission main was installed from the Gilman Park Well site to convey the produced water from the restored well to the new groundwater treatment facility.

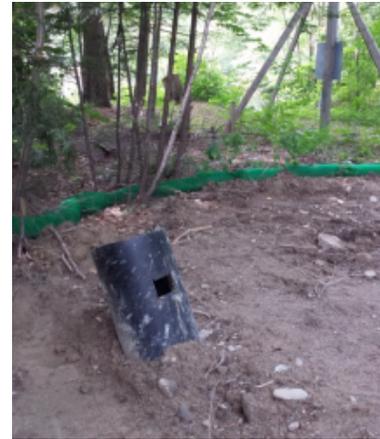
The Stadium Well was constructed in 1963 and remains inactive since being abandoned prior to 1986. The 36-inch by 24-inch diameter originally constructed gravel-packed well was between 54 and 59 feet deep. Currently there is no building to house the well pump and controls. The well site is being considered to provide water to the new groundwater treatment facility, and in April 2015 a 30 year lease was executed between the Town of Exeter and Phillips Exeter Academy. When this well is reactivated, all new equipment and controls will be required.

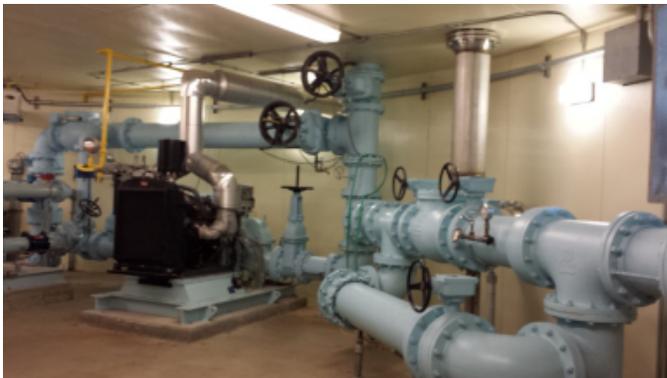
The Epping Road Booster Pump Station was constructed in 2008 at the base of the Epping Road water storage tank. The concrete pedestal tank base was split into two separate compartments. One section is enclosed and houses one jockey pump that runs continuously and two booster pumps that operate based on demand. They are used to pump water from the Main Service Area to the 258 foot HGL of

the Industrial Drive High Service Area. The facility also houses one natural gas fired, high service fire pump with a capacity of 4,600 gpm. The facility includes a hydropneumatic tank, SCADA equipment, and miscellaneous electrical equipment. Within the tank and booster pump station perimeter fencing is an enclosed generator on a concrete pad.

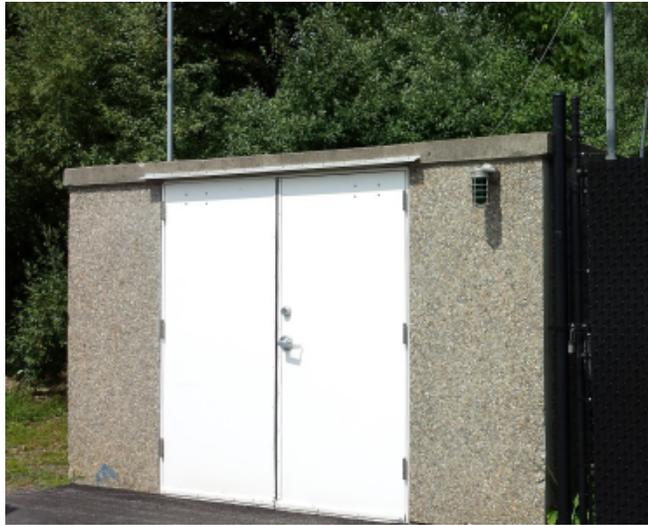
The Kingston Road Station was originally constructed in 1985 as a booster pump station. In 2008 the Epping Road water storage tank was constructed and raised the main service area HGL by 30 feet to 235 feet. This eliminated the need for a booster pump station to raise the HGL to the Kingston Road Service Area HGL of 224 feet. In 2008, the Kingston Road facility piping was modified to remove the pumps and install PRVs that are operated based on the flow through the facility and the Cross Road Tank water level. The modifications converted the facility to function as a PRV facility to control gravity flow to the Kingston Road Service Area. A chlorine analyzer was also added as part of the facility modifications. The facility no longer acts as a booster pump station, but instead is used to lower the HGL and monitor chlorine levels in the water distributed to the Kingston Road Service Area. A gate valve was also

added to the existing water main within Kingston Road to allow the Kingston Road Service Area to be isolated from the Main Service Area.

The facility is located on Kingston Road, approximately 150 feet north of Brickyard Pond Park. The facility is constructed of precast concrete panels and supports a concrete plank roof. The facility houses a magnetic flow meter, two (2) electric butterfly valves and pressure transducers, a calcium hypochlorite booster chlorination system, and a portable generator. The chlorination unit is a Power Pro calcium hypochlorite tablet feed chlorination unit by Accu-Tab Systems which was installed to boost chlorine residuals.

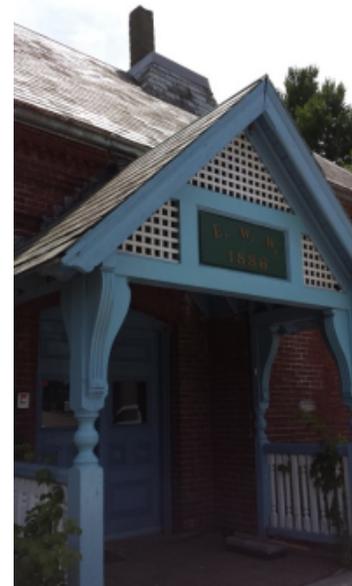
The Exeter Surface Water Treatment Plant was constructed in 1886. The original brick building is in poor condition and was condemned in 1992 due to deterioration of the floor timbers.

The treatment plant filter building was constructed in 1906. The facility was updated and expanded in 1972. The brick building houses laboratory equipment, a SCADA system, carbon feed machine, three finished water pumps, four carbon filters, filter mag meters, a polyaluminum chloride tank, two polyaluminum metering pumps, a caustic tank, and two caustic metering pumps. This facility houses two 50 hp backwash pumps. The roof was replaced in 2014.

The garage was built in 1972 to house chemical feed equipment for the water treatment plant. The chemical feed equipment includes chlorine tanks and metering pumps, a permanganate tank and metering pumps, and a filter aid tank and filter aid metering pumps. The two active garage doors are currently in need of replacement.

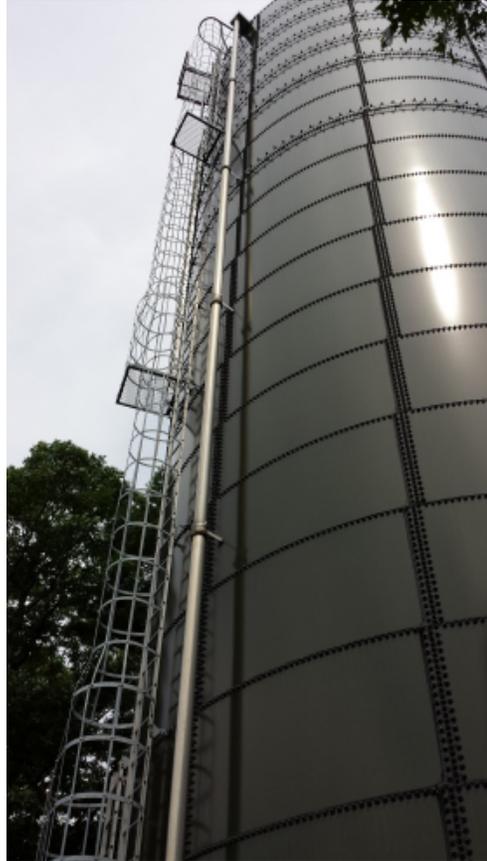
Since the potential for a spalling problem was identified in 1995, the Cross Road Tank has been inspected several times. In 1999 Aquastore® installed cathodic protection, at no additional cost to the Town, and extended the corrosion warranty to 2018. In 2013 a leak was discovered near a seam between steel plates. The leak was repaired by Aquastore® in 2013. Based on a brief exterior visual inspection completed by Tata & Howard there were several areas along the tank base where rocks had pierced and broken through the glass layer causing rusting. There was also a leak located approximately 55 feet from the base of the tank. Aquastore® repaired this leak in the fall of 2014. Another leak was discovered by the Town in April 2015. The Town has contacted Aquastore® to report the leak and a repair will occur soon.

According to the 2002 CDM report, an accidental overfilling of the Cross Road Tank occurred during a winter in the late 1990's while ice was present within the tank. When the exterior tank warmed, the rapidly rising ice layer collided with the tank roof system, resulting in \$20,000 in roof damage, which required immediate repair.

The Town’s Cross Road Water Storage Tank is a glass fused to steel standpipe constructed in 1993. The tank has a capacity of approximately 0.48 MG and stands approximately 86 feet tall and is approximately 31 feet in diameter. The overflow elevation is 224 feet. A GridBee GS 12 tank mixer was installed in November 2014.

We would anticipate the life span of this tank to be beyond the 20 year planning period for this study. Based on the fairly recent tank construction, the tank is in good condition. However, during the tour the tank was leaking and there were several locations along the bottom ring that were missing the glass layer, likely due to rock damage. Two leaks were repaired by Aquastore in the fall of 2014. The tank should be closely monitored and inspected a minimum of every three years per the NHDES standard recommendation. The Cross Road Water Storage Tank is scheduled to receive inspections by Aquastore every three years. The next inspection is due in early 2018. Since the tank is surrounded by foliage it may soon require an exterior pressure wash to remove organic material and mold that can accumulate on the exterior walls. A security fence does not exist at this site. It is recommended that a security fence be installed to deter malicious tampering and graffiti.

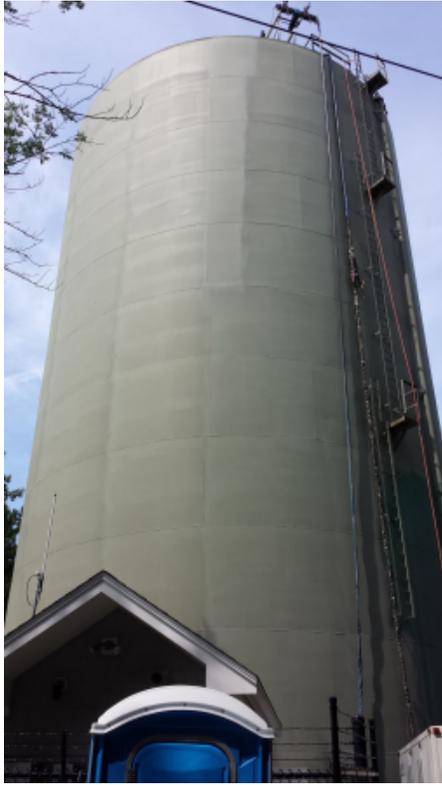
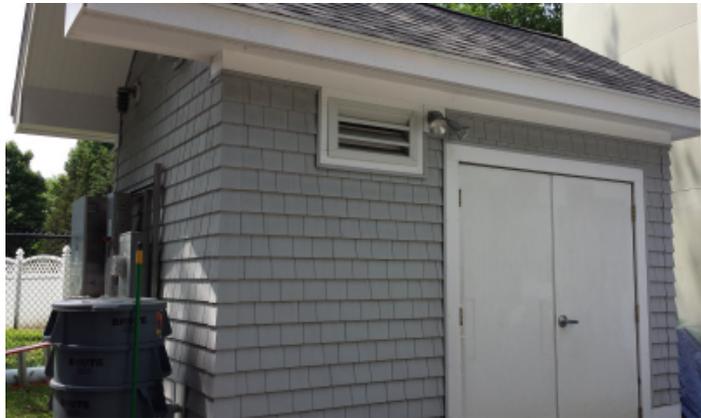
The Hampton Road Water Storage Tank is a steel standpipe constructed in 1958. The tank has a capacity of approximately 1.0 mg and stands approximately 85 feet tall and is approximately 46 feet in diameter. The standpipe appears to be in good condition, and we would anticipate the life span of this tank to be beyond our planning period. A full interior and exterior rehabilitation was completed by Utility Service Company in the fall of 2014. The rehabilitation included installation of an active PAX mixing system. A portable generator is located at the standpipe. In 2014, the Town executed a 12 year contract with Utility Service Group to provide inspection and maintenance services for the Hampton Road Tank. NHDES standards recommended that tanks are inspected every three years. The Hampton Road Water Storage Tank would be due for an inspection in early 2018.

There is an existing concrete vault and wood framed telemetry, storage, monitoring, and pump station building constructed near the tank. This building was constructed in 2008. The vault contains a 10-inch check valve, a 6-inch electric actuated butterfly valve, which acts as an inlet isolation valve, and a 6-inch altitude valve. The automatic settings of the inlet isolation valve close the valve when one or more booster pumps are running and open the valve when no pumps are running. The valve may be placed in manual mode, and would allow an operator override the settings.

The building contains a Generac portable generator, wall mounted unit heater, pressure transducer, pump controls, chlorine analyzer, PAX mixing system control box, and SCADA panel. The building and equipment appear to be in excellent condition. Constructed in 2008, east of the building, was a duplex pitless booster pump station housing two 210 gpm submersible pumps. The site is fenced and the access gate is locked to prevent unauthorized access. The recommendations are summarized in Table No. 6-1 of the Recommendations Section.

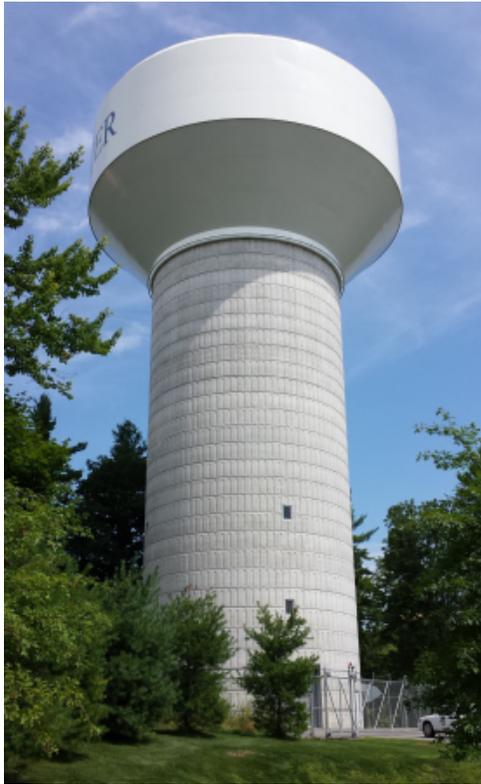
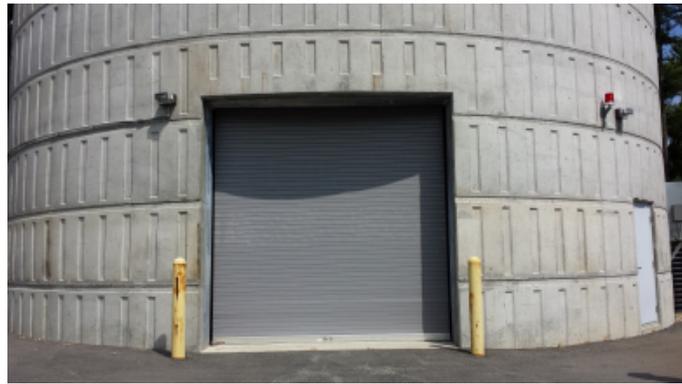
The Epping Road Water Storage Tank is a composite elevated tank constructed in 2008. The tank has a capacity of approximately 1.5 MG, maintains a water depth of approximately 40 feet, and is approximately 87 feet in diameter. Measured from the ground elevation at the tank base, the height to the bottom of the tank is 117.5 feet and the height to overflow is 157 feet. The overflow elevation is approximately 235 feet. The tank serves the main service area. The tank appears to be in excellent condition, and we would anticipate the life span of this tank to be well beyond our planning period. NHDES recommends that tanks are inspected every three years. The Epping Road Tank is due for an inspection in 2015.

The concrete base of the tank is divided into two sections. One side is open and provides general storage, the other side is enclosed and houses several pumps, a hydropneumatic tank, SCADA equipment, and miscellaneous electrical equipment. An emergency generator is located outside the tank base. All equipment was installed in 2008. The equipment appears to be in excellent condition and the anticipated life span is well beyond our planning period. The water storage tank does not contain a mixer, however the Town is planning to install a mixer in this tank. The Town is considering entering a service contract with Utility Service Group to inspect and maintain the Epping Road tank. The recommendations are summarized in Table No. 6-1 of the Recommendations Section.
